Titus
Inspections

Inspection Report

Property Address:
13031 Villosa Pl #425
Playa Vista CA 90094

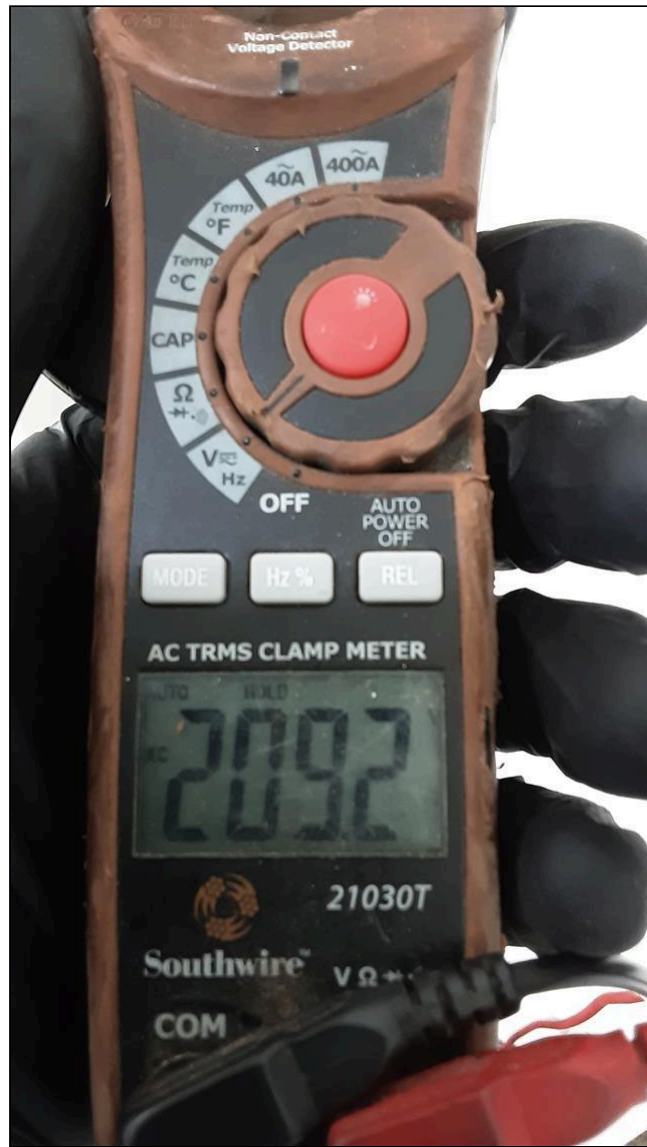
4.3 Item 1(Picture) Voltage

4.3 Voltage at main distribution panel was 209.2 volts at time of inspection.

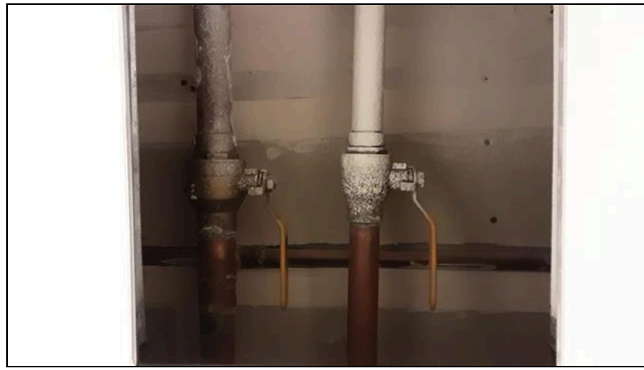
5.0 Item 1(Picture) Main water shut off

5.0 The main water shut off for hot and cold water supply is located inside the second bedroom bathroom ceiling.

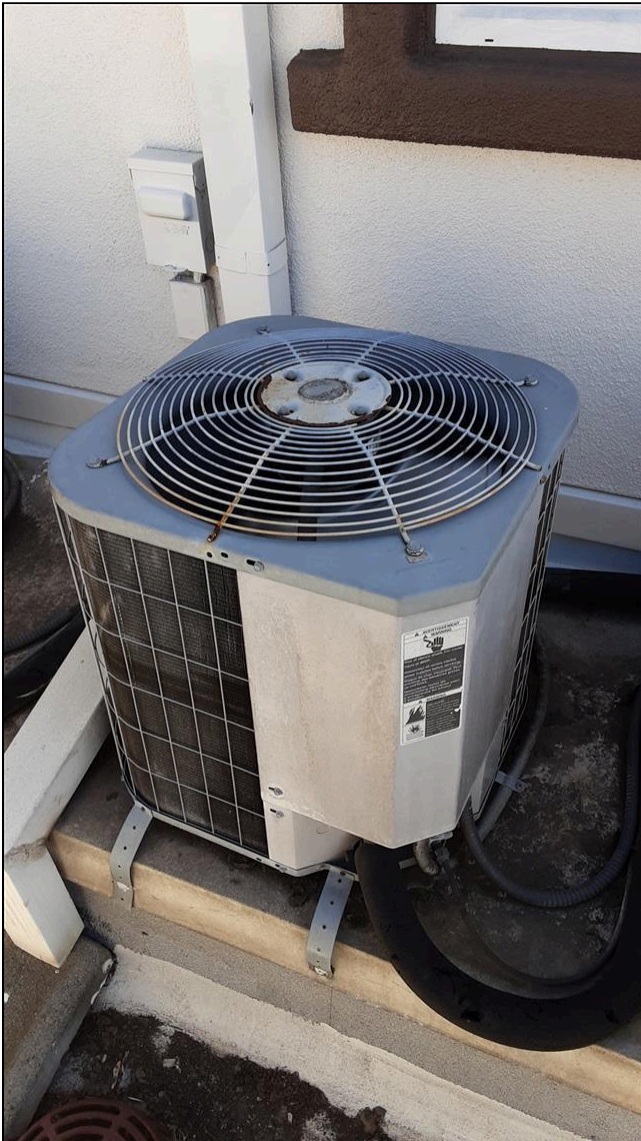
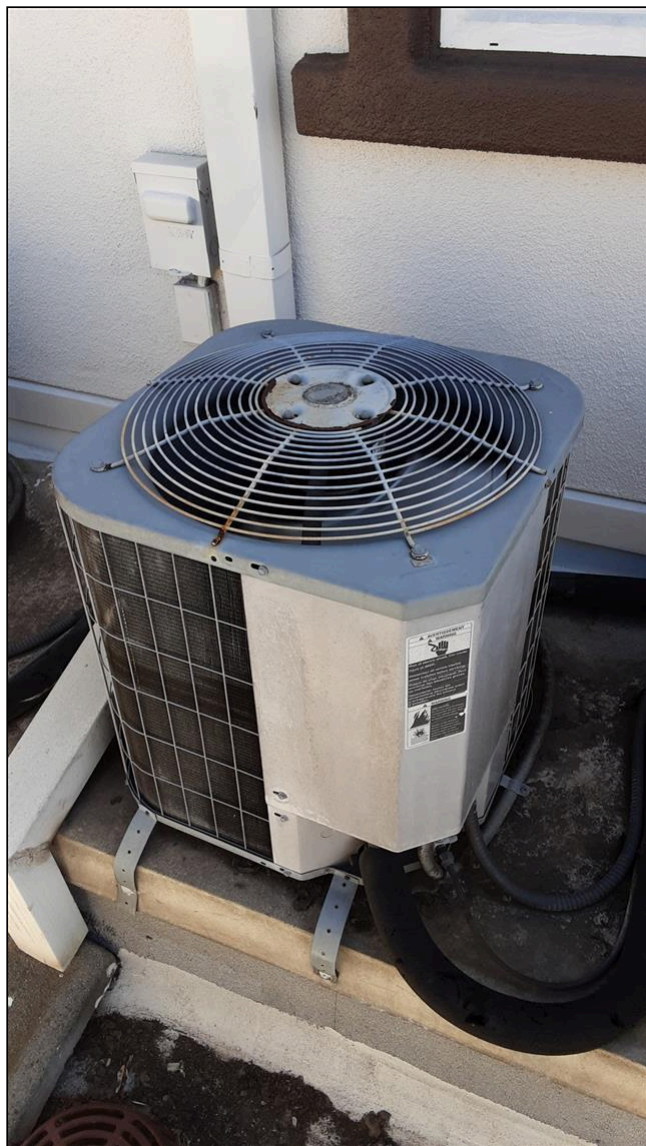
8.0 Item 1(Picture) Heat pump #1

Manufacture date: Not visible (Unable to identify age of system. System appears to be original from 2006 build. Recommend servicing and maintenance by a qualified HVAC technician as needed.)

8.0 (3) Heat pump system #1 and #2 use R-22 refrigerant. This refrigerant has been phased out and is no longer available. Some HVAC technicians may have reclaimed or recycled refrigerant but expect the price for repairs to be high. This may force you to replace the system completely to avoid high repair cost. Contact a qualified HVAC technician for further information.

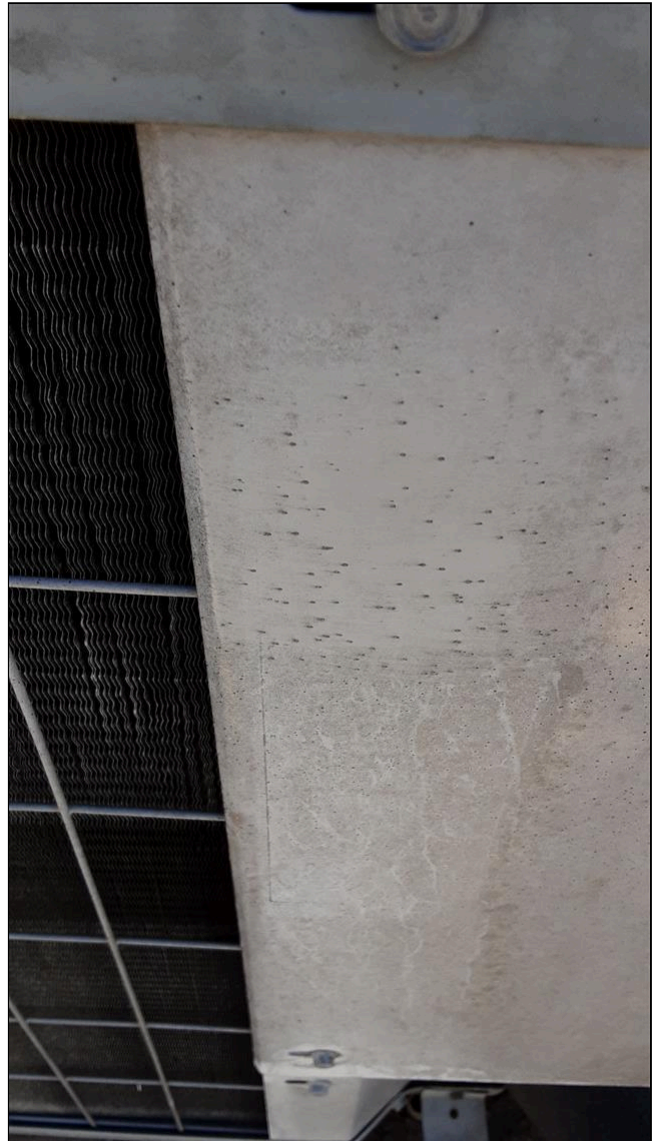
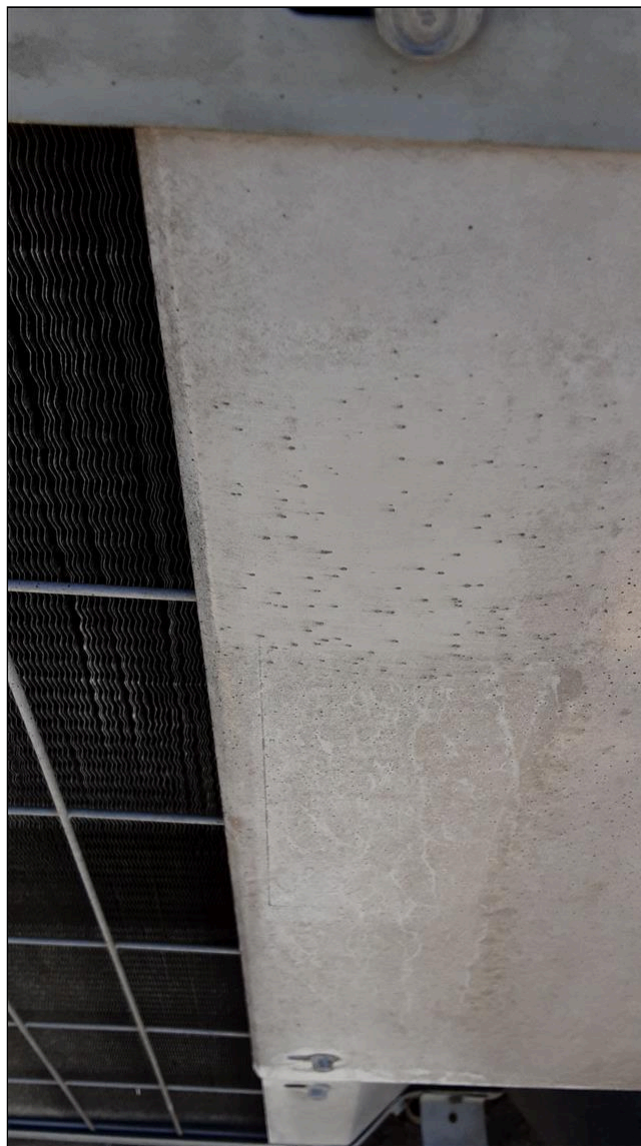
8.0 Item 2(Picture) Heat pump #1 info label

Model: Not visible

Serial: Not visible

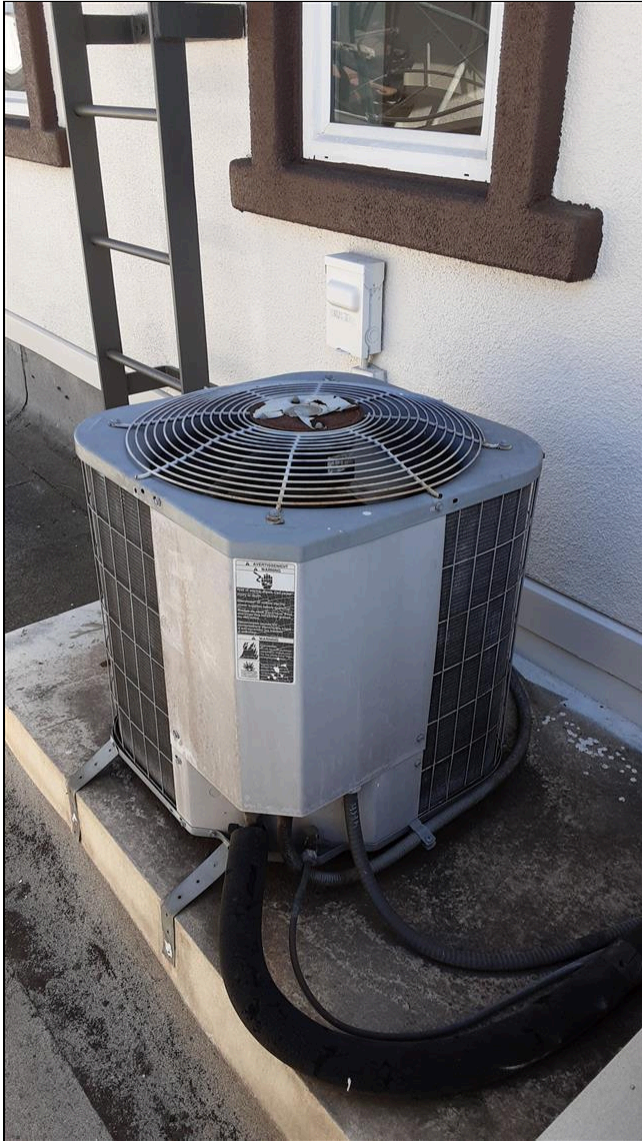
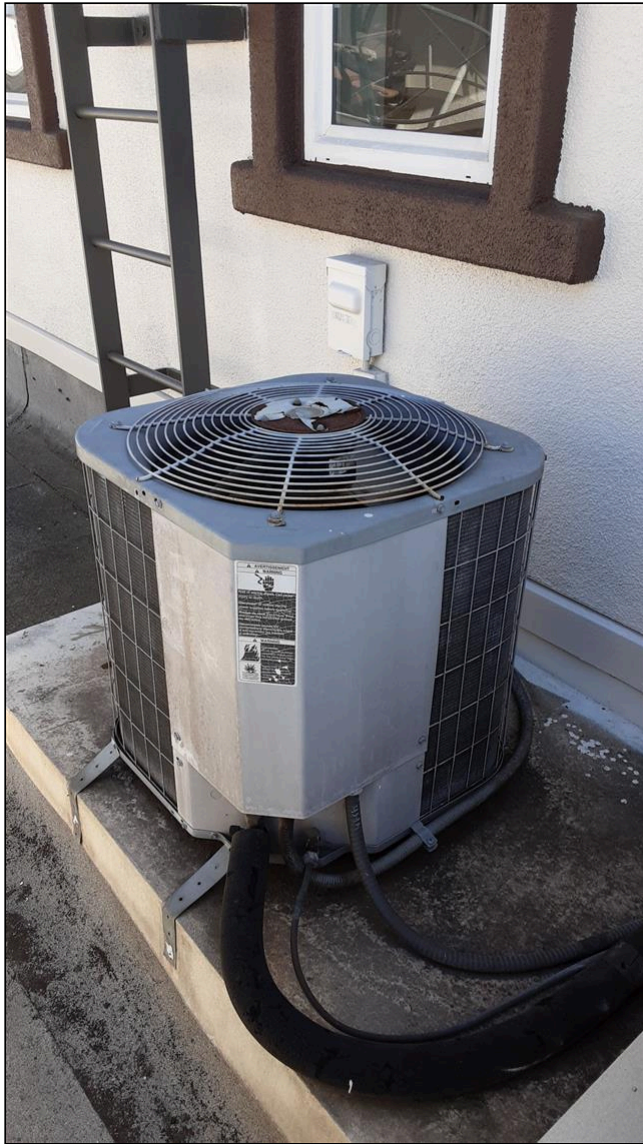
8.0 Item 3(Picture) Heat pump #2

8.0 (2) Heat pump system #2 (also provides cooling) is located on the rooftop.

Manufacture date: Not visible (Unable to identify age of system. System appears to be original from 2006 build. Recommend servicing and maintenance by a qualified HVAC technician as needed.)

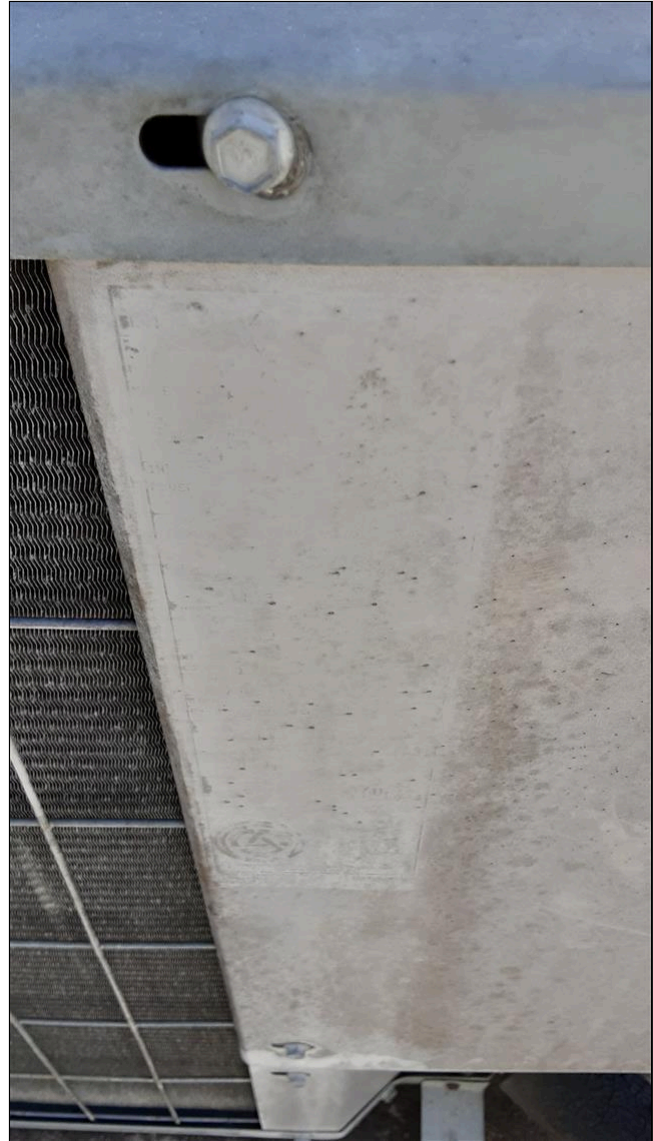
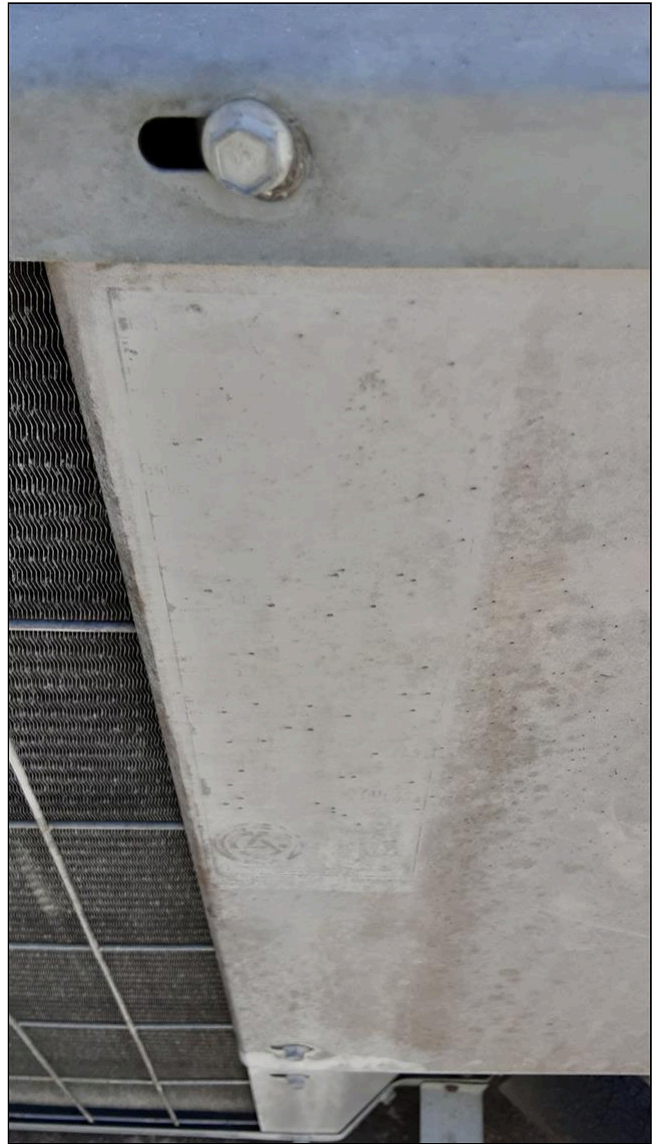
8.0 Item 4(Picture) Heat pump #2 info

Model: Not visible

Serial: Not visible

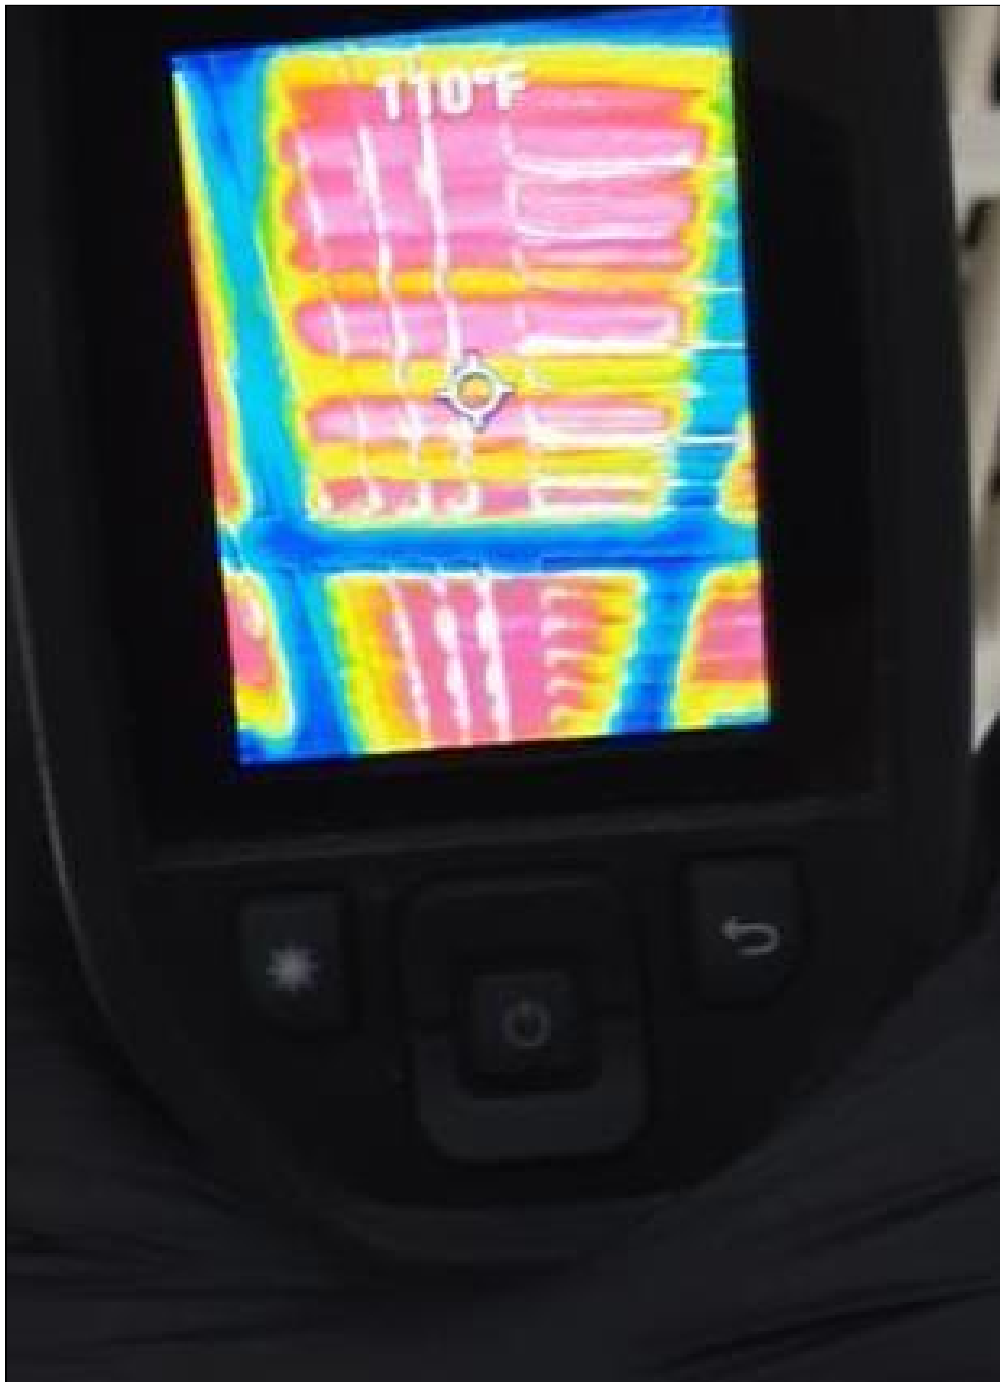
8.1 Item 1(Picture) Heat system #1 temp, main floor

8.1 Heat system #1 heating temperature at main floor registers was 110 degrees at time of inspection.

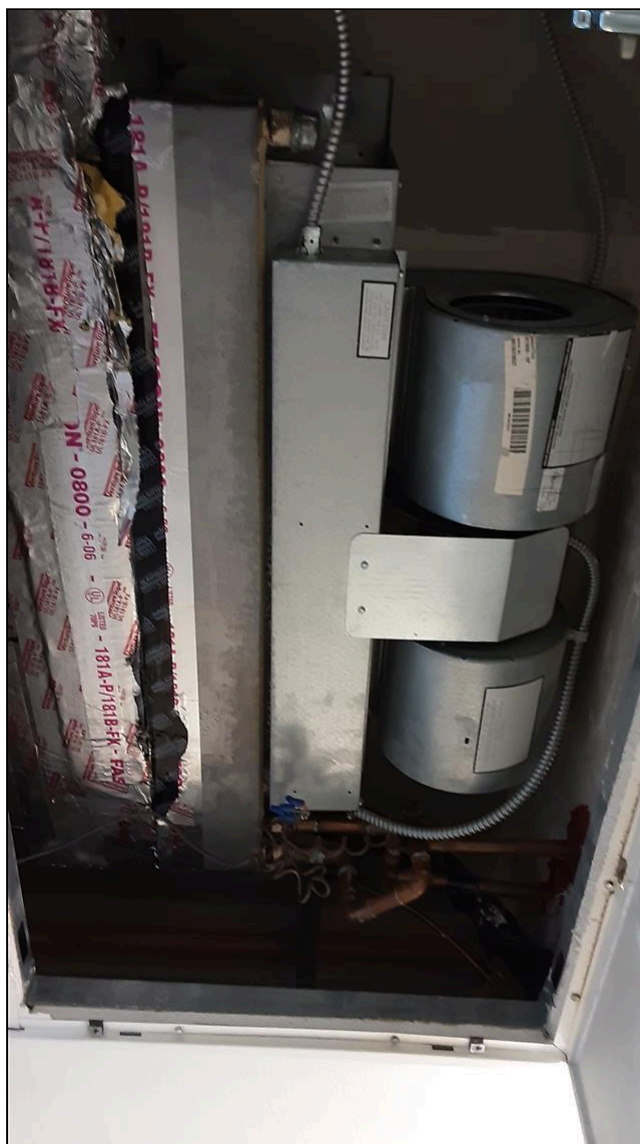
8.3 Item 1(Picture) Fan coil #1

8.3 (1) Fan coil #1 for heat pump #1 is located inside powder room ceiling.

Manufacturer: First Co

Model: 18HXO-51

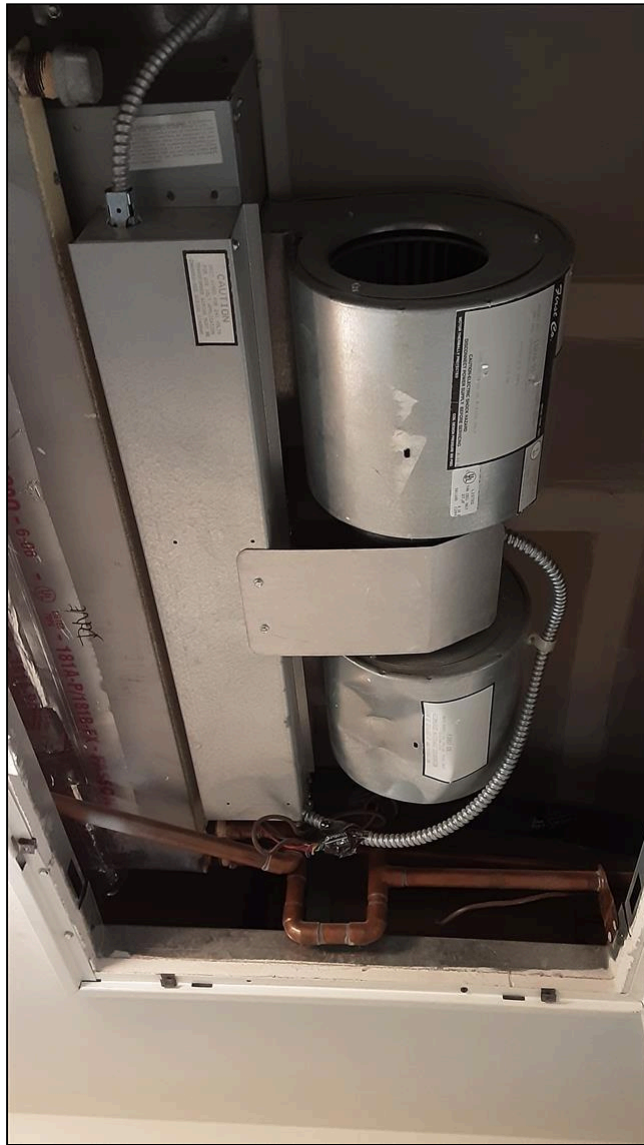
8.3 Item 2(Picture) Fan coil #2

8.3 (2) Fan coil #2 for heat pump #2 is located inside master bedroom closet ceiling.

Model: 18HXO-51

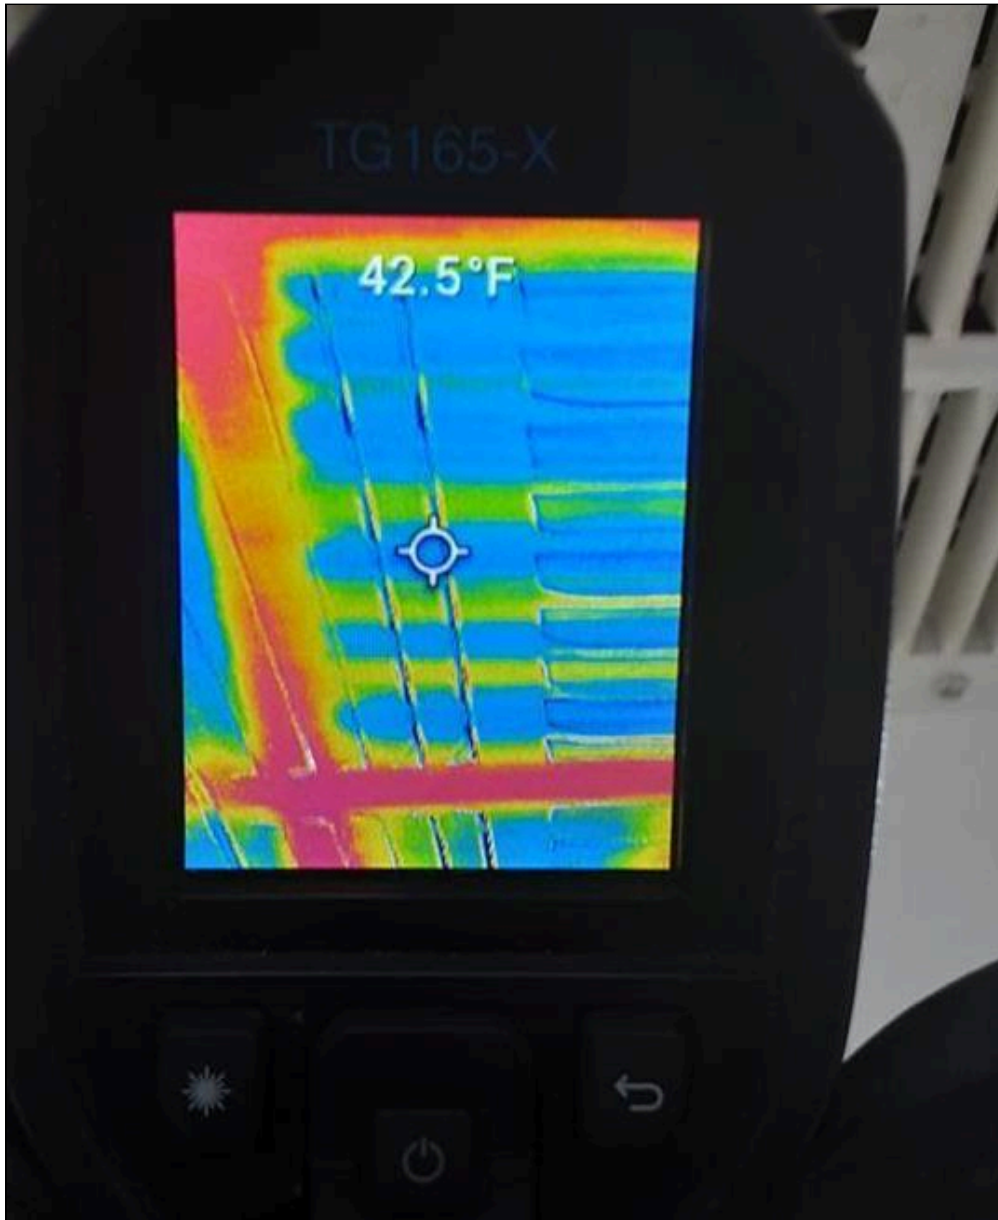
8.7 Item 1(Picture) Cooling system #1 temp, main floor

8.7 Cooling system #1 temperature at main floor registers was 42.5 degrees at time of inspection.
